CLIMATE CHANGE AND SLOPE STABILITY OF THE ACCESS ROAD, LUNDY, BRISTOL CHANNEL

JOHN GRIMES, ANDREA ROBERTSON AND MARK BURROWS

John Grimes Partnership Ltd, Leonards Road, Ivybridge, Devon, PL21 0RU

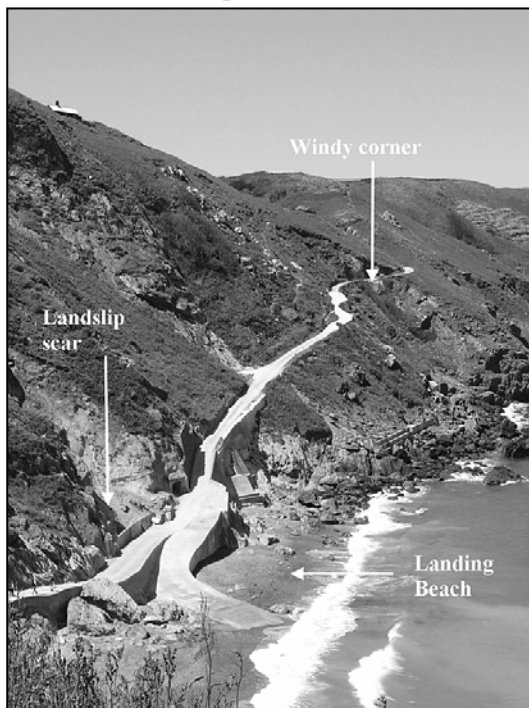
The access road from the Landing Beach rises steeply (10°) and transverses the coastal slope of marginal stability, as shown in Figure 1. The new slipway and elevated section of road at the Landing Beach completed in the summer of 2009 is also shown in Figure 1.

Figure 1: Overview of the Landing Beach and access road along the coastal slope. The landslip scar to the rear of the Landing Beach is the site of retrogressive slipping triggered by marine erosion in the late 1990s

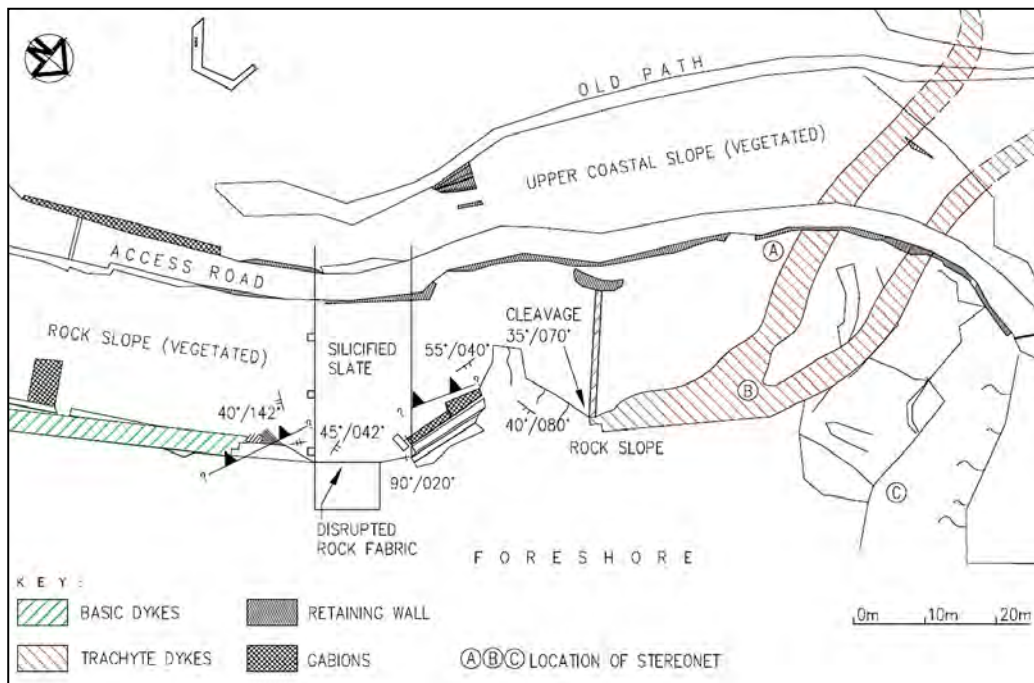
Figure 2: Simplified geology plan of area of Phase I access road stabilization works

The meta-sedimentary rocks observed predominantly comprised greenish grey, moderately weathered slates and phyllites. Analysis of the slates and phyllites indicated that they are generally moderately strong. In addition, several igneous dyke intrusions were recorded. Both basic and trachyte dykes are present. The dykes tended to be sub-vertical and linear, and in places easily traced over considerable distances (> 200 m). The width of the dykes was generally less than 2 m and sometimes less than 1 m. The dykes are typically slightly stronger and less fractured than the meta-sediments into which they are intruded. However, locally it was observed that the dykes were much less competent and almost decomposed to form a residual soil. The contact between dykes and the sediments was often faulted and brecciated with some alteration of the rocks.

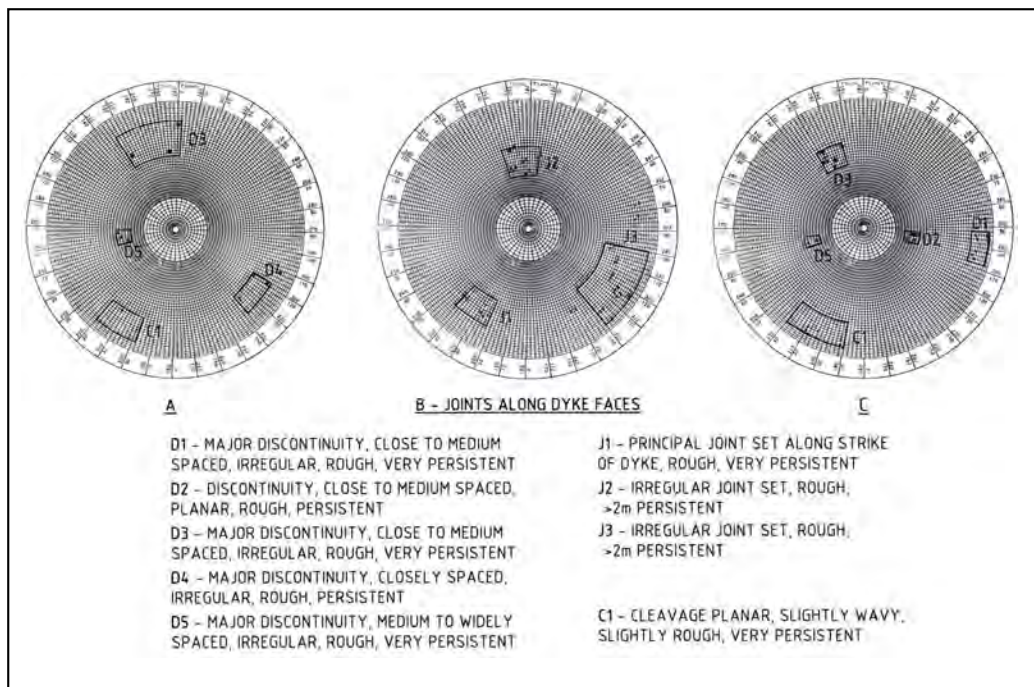
In respect of the slate, this typically had a well-developed and prominent cleavage tending to be both smooth and wavy with kink bands evident in some areas. The phyllites were less perfectly cleaved. Generally there was a second discontinuity set sub-parallel to the cleavage, which denoted bedding. The cleavage/bedding orientations were variable at different locations, indicative of folding, though no folds axes were observed during the fieldwork. Faults and major joint discontinuity sets were identified, often steeply inclined and orthogonal to the cleavage/bedding planes. Thrust faults sub-parallel to the cleavage were also observed. Some of the discontinuities are highly persistent and planar. The geomorphology is determined to a large extent by these planes. Lower hemisphere equal area stereographic plots recording rock mass discontinuity geometry are recorded in Figure 3.

Figure 3: Example stereographic plots of significant discontinuities (locations shown in Figure 2)

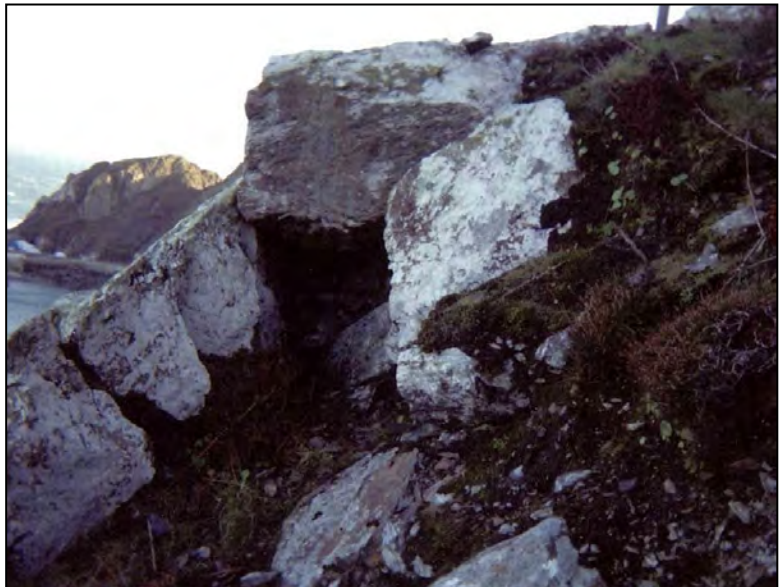
During site investigations and piling works along the access road, the extremely disrupted and dilated rock mass fabric was evident on the coastal slopes and foreshore. These features are indicative of ice plucking; i.e. an ice wedged open fabric. This open texture and juxtaposition of many of the boulders on the steep rock slope is more indicative of a basal tilt than landslip (Figure 4).

Figure 4: Example of open texture of exposed rock and juxtaposition of boulders

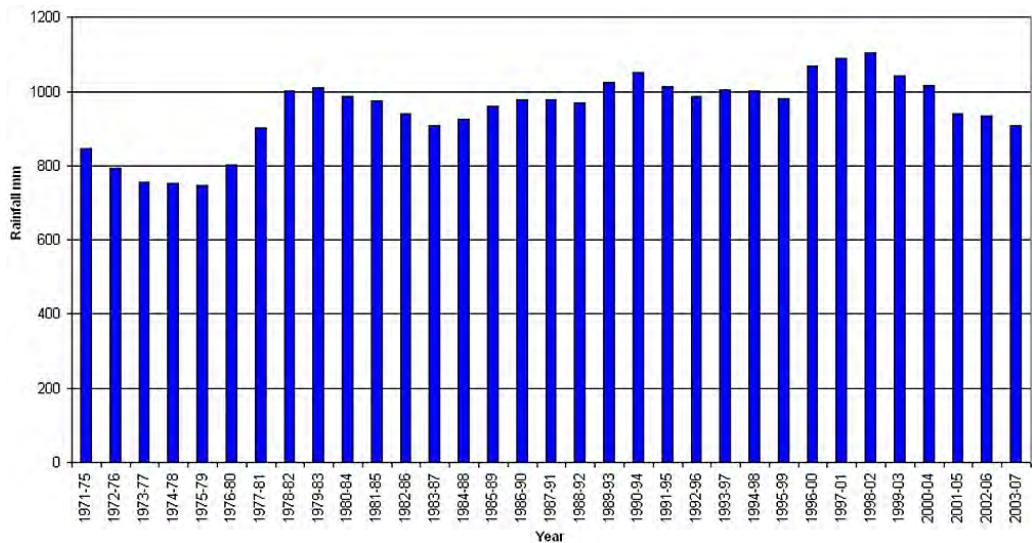
Figure 5 (*overleaf*) shows the moving 5-year annual average rainfall for the island (rainfall data provided by Landmark Trust), which suggests an increase of nearly 10% in average annual rainfall over a 35-year period. A subjective observation in respect of rainfall patterns is that it tends to include one or several high intensity, but relatively short duration episodes rather than prolonged low intensity rainfall. These high intensity events are particularly likely to trigger instability.

Figure 5: Five-year moving average rainfall data (source Landmark Trust) which indicates a steady increase in rainfall

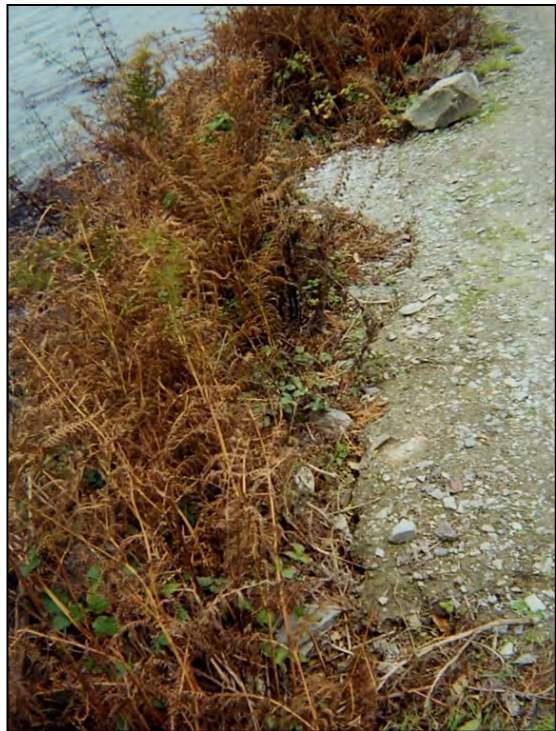
For several years prior to reconstruction, movement had been recognized along the section of road ascending the coastal slope. Much of the original track along this section was retained by dry stone walling. Although the rockhead is relatively shallow, the dry stone walls were constructed on talus or ancient slip debris above the rock. The walls were also inadequate and increasingly showing distress; they were becoming dilapidated, bulging and slipping down slope. There have been localised collapses of the walls, tension cracks along the road and above retaining walls opened and progressive subsidences were evident (see Figure 6). Small magnitude (< 1 tonne) landslips from above the road were a common occurrence. In places, angled sectional steel had been driven into the ground to provide additional support to the retaining wall on the downslope side of the road. Walls were in a very poor condition with a high risk of sudden collapse under loading, particularly during wet weather. They were also inadequate to proffer any restraint against landslip and to mitigate such an occurrence.

Figure 6: Tension cracks along edge of road prior to stabilization works (OS Grid Ref: SS 14150 43950)

The new retaining structure (OS grid ref: SS 14190 43905 to SS 14140 43958) was formed by steel reinforcement sprayed concrete, constructed over the existing road.

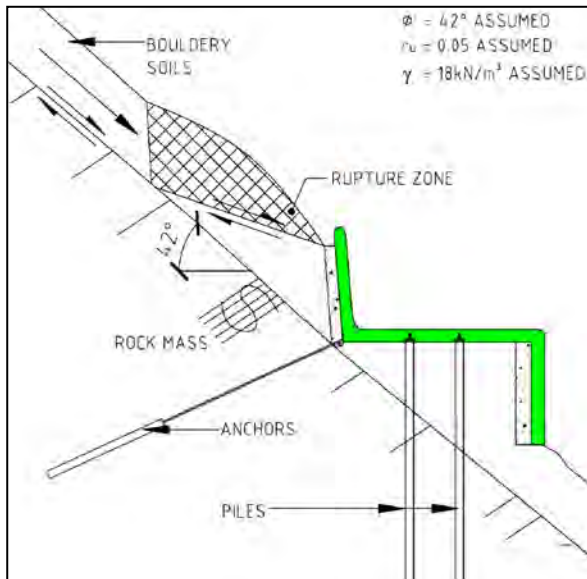
Figure 7: The conceptual model for stabilization of the access road across the coastal slope (Grid Ref. SS 14190 43905 to SS 14140 43958)

Piles were extended into the ground to provide an adequate rock socket below the level that rock joints were found to be dilated and below which the ground could be adversely affected by sliding in the lower slope. The up-slope section was designed to resist any pressure generated by down-slope sliding. Grade 316 stainless steel anchors were extended between 6m to 12m into the rock depending on its quality to resist down slope movement. The reinforced sprayed concrete arrangement is a continuous stiff structure. Should part of the structure be heavily impacted by landslide, the load will be effectively shared by adjacent structures.

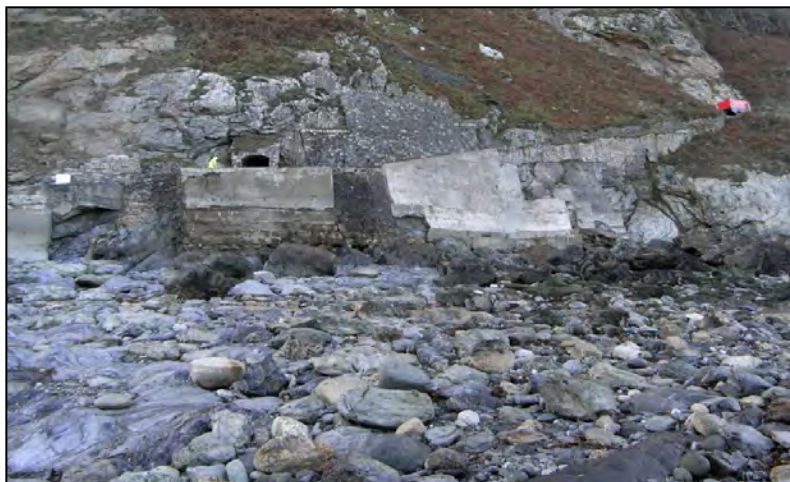
The landing beach is a wave cut platform covered with slaty shingle. The beach has always tended to be undernourished and highly mobile. The sediments that accreted in the summer months were typically rapidly deflated in winter. The beach had been systematically deflating over the past 20 years. In 1989-1990 it was substantially recharged with sediments derived from the blasted excavation of the road across the promontory. Prior to the recent slipway reconstruction works, the beach was deflated to the extent that large areas of bare rock were exposed (Figure 8).

Figure 8: Deflated beach during winter months. Base of quay wall undermined and rock exposed on beach

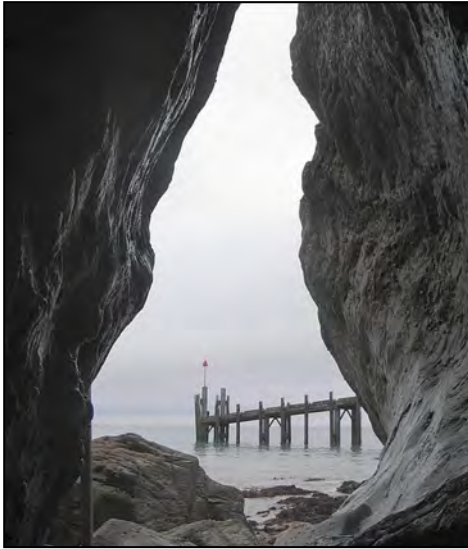
Marine erosion has always exploited both weak lithologies and structural geologic weaknesses in the hard rock sea cliffs (Figure 9). The slates are also faulted and distorted, with faulting frequently parallel to the cleavage. Intra-cleavage fault zones of loose brecciated material are easily eroded. An example is evident to the rear of the sentinals. Such faulting along which rapid erosion has occurred is evident in the protected sea cliff extending out to form the promontory (SS14375 43728).

Figure 9: A large sea cave which undermined the beach road (OS grid ref: SS 14430 43780). A protective facing was constructed across it as part of the necessary works

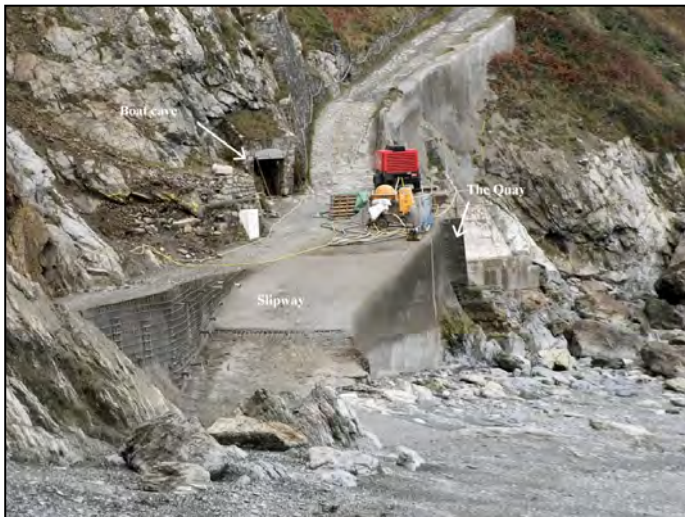
Figure 10: Overview of the Landing Beach during works

These works involved localised reinforced gunite protection of the major geologic weaknesses in the sea cliffs where these were being significantly eroded by storm wave action, to the potential detriment of the road. The landing beach slipway had deteriorated to an unusable condition as a result of marine erosion. To the south east of the boat cave, marine erosion was also the initial trigger for the retrogressive sliding in the cliff/steep slope to the rear of the road. Elevating the road afforded necessary protection to the cliffs but also improved access (Figure 10).

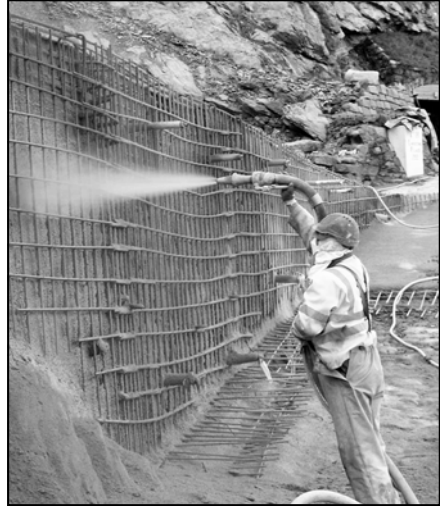
Figure 11: Spraying of gunite to rear of slipway

Structure of the road consisted of an anchored reinforced gunite retaining wall backfilled with fragmented slate derived from scaling The Saddle (Figure 11). Reinforcement was grouted into competent rock at regular centres to form vertical cantilevered beams. Such an arrangement is referred to as 'soldiers'. The soldiers were restrained against outward movement by anchors extending into the cliff. A reinforced gunite wall was formed by spanning reinforced concrete horizontally between the 'soldiers'.

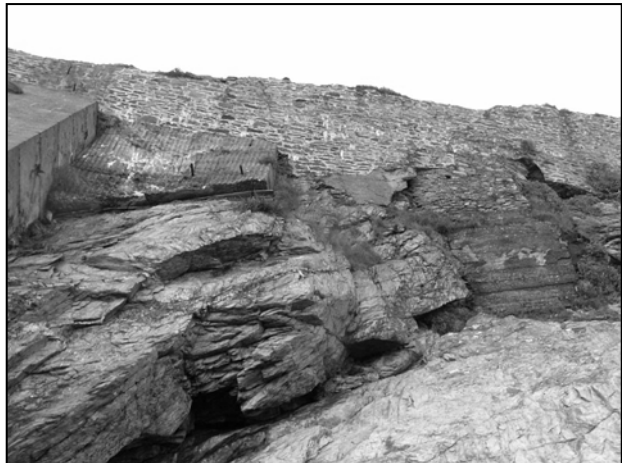
The existing revetments forming the Quay (SS14255 43830) and cliff protection to the north east were also in a poor state of repair (Figure 8). Severe basal abrasion and extensive undermining was evident. A high level masonry retaining wall (Figure 12) had cracked and exhibited recent movement and was considered to be in danger of sudden and catastrophic collapse. Engineered works included the construction of anchored reinforced gunite strengthening to the existing revetments (Figure 13), gunite infill of erosion features and the construction of anchored reinforced gunite protective aprons (Figure 14). The aprons reduced the risk of quarrying type erosion.

Figure12: High-level wall retaining access road which displayed cracking and was considered to be in danger of collapse

The high level wall (Figures 12 and 13) was strengthened as part of Phase II works. The rock slope below the road (Figure 12) was susceptible to landslip, which could be triggered by storm wave activity. The rock was underpinned and secured.

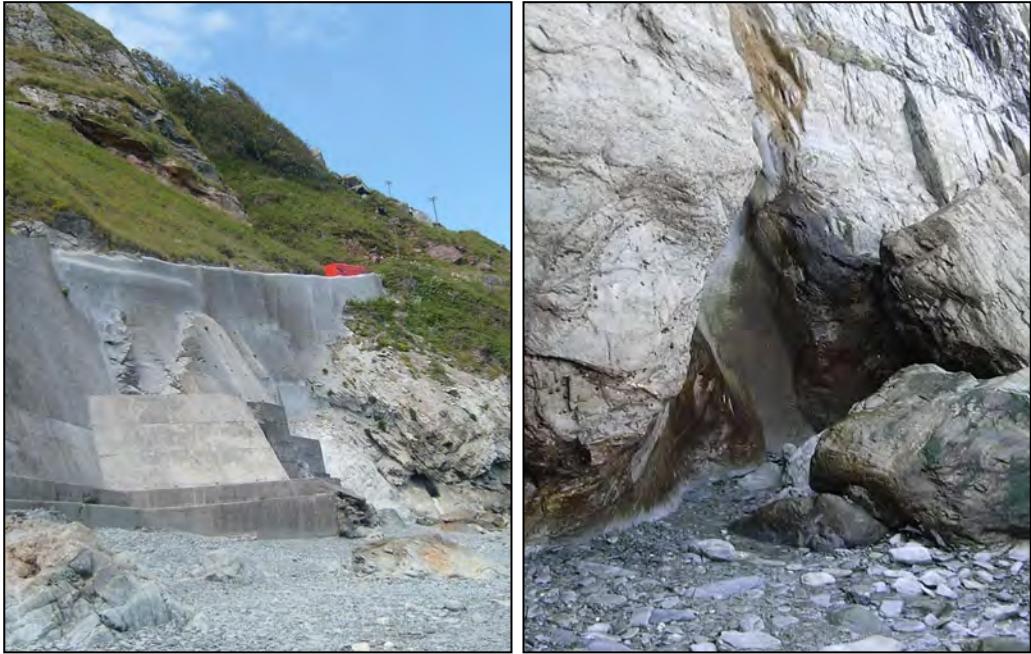
Figure13 (left): Completed works to the quay and revetments. **Figure 14** (right): Guniting facing to the sea cave (Figure 9)

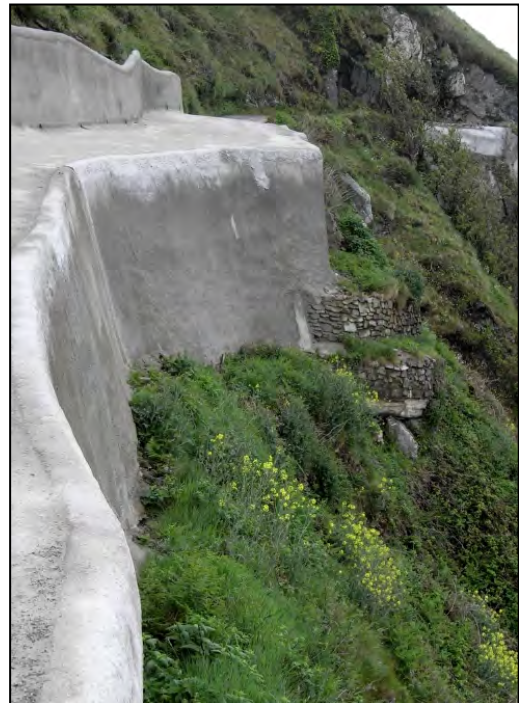
Figure 15: Photograph of access road almost one year after works showing Lundy Cabbage in the foreground re-established immediately adjacent to sprayed concrete wall
